CASE REPORT***Orthodontic Extrusion of Subgingivally Fractured Incisor and Prosthetic Rehabilitation: A Case Report.***Ragheeba Ansari¹, Swatantra Agarwal², Abroo Hussain¹, Dipti Nayak¹**ABSTRACT**

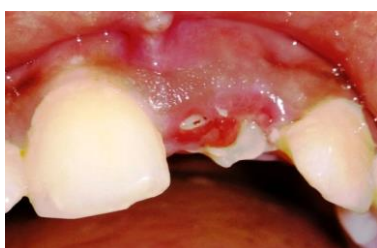
A 22-year-old male patient reported to the department with the chief complaint of fractured maxillary left permanent central incisor (figure 1).

FIGURE 1: Subgingivally fractured maxillary left permanent central incisor

History dates back to one day when patient met with trauma that caused uncomplicated subgingival fracture of the same tooth at cervical third of the root. Gingival inflammation was reported with respect to a fractured tooth with no mobility and tenderness on percussion. There was no significant past medical history. Clinical and radiographic maxillofacial examination revealed that there was no fracture of the maxilla, mandible, or other facial bones. Further a definite treatment plan was made and explained to patient. Gingivectomy was done irt 21 followed by root canal treatment (figure 2). Orthodontic extrusion of the fractured permanent maxillary central

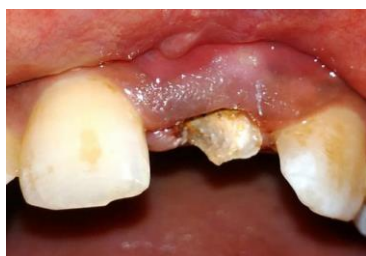
FIGURE 2: After Gingivectomy And Root Canal Treatment

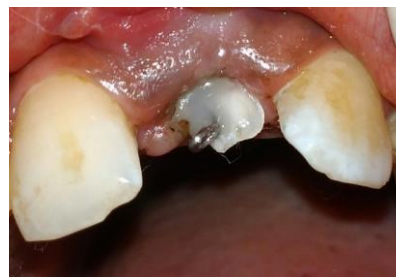
incisor was required to move the palatal fracture line approximately 3 mm above the alveolar crest in order to regain the lost biologic width. Orthodontic traction was applied using a maxillary appliance with V-shaped bend with respect to area of maxillary left central incisor and a hook shaped wire placed over fractured tooth (figure 3).

Figure 3: Wire In Shape Of Hook Attached To Fractured Tooth

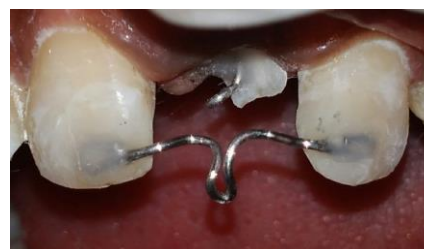
V-shaped bend was placed approximately 5-6 mm below the alveolar crest level of tooth attached to the adjacent tooth with help of composite (figure 4). Extrusive force was applied using elastics tied with hook shaped wire and V-bend

Figure 4: V Shaped Bend Given In The Wire

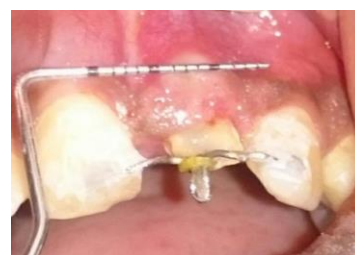
. Elastics were changed every week to assure continuous traction force and regular oral hygiene maintenance. An extrusion of 3 mm was obtained in 2 months, which was appreciated clinically and radiographically (figure 5).

Figure 5: V Shaped Bend And Hook Joined With Elastics

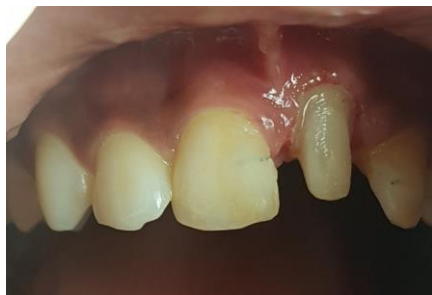
Figure 6: Fiber Post and core build up

Post space was prepared, and a prefabricated fibre post was cemented in the canal using glass ionomer cement (figure 6). Core build-up was done, and tooth was restored with lithium disilicate crown (figure 7 and 8).

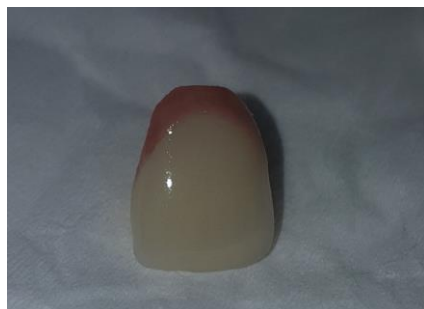
Figure 7: Lithium Disilicate Crown

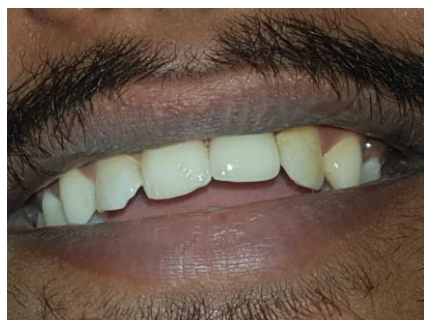
Figure 8: Cemented Prosthesis
